The 2020/2021 RRWA Water Quality Monitoring Program

Locations Monitored in 2021 and Results

Rahway River Watershed Association Monitoring Sites

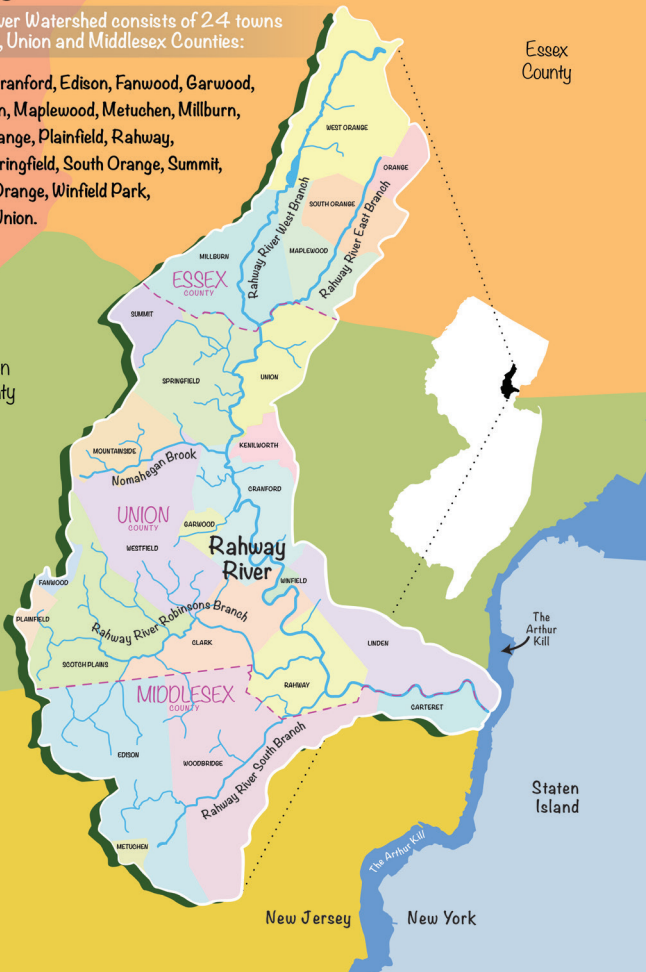
The Rahway River Watershed consists of 24 towns spanning Essex, Union and Middlesex Counties:

The Rahway River runs through Essex, Union, and Middlesex counties, draining 41 square miles of land in 24 municipalities, as shown on the watershed map.
