Water Quality Assessment Report

January 2019

Introduction

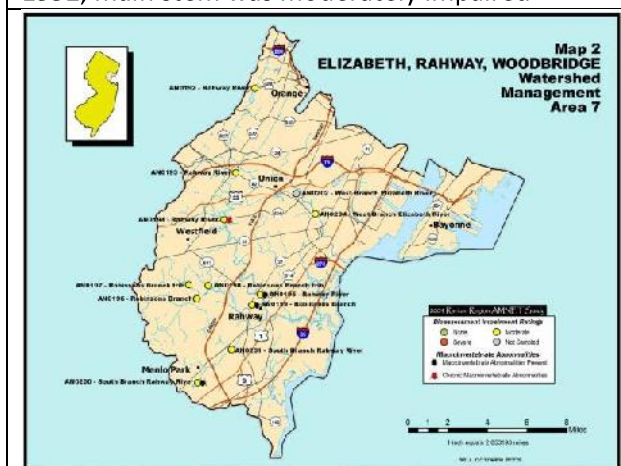
2004, most sites were moderately impaired

Maps show sampling sites in 1992, 1999, 2004, and 2009, indicating the level of impairment.

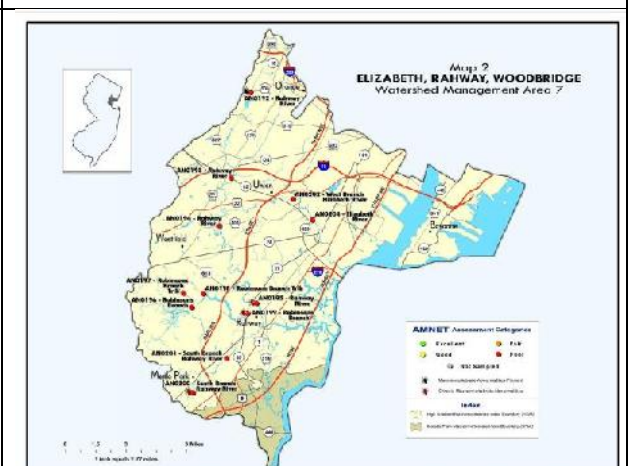
2009, all sites were scored as poor

All sites on the Rahway River and its tributaries scored as “poor” in 2009, the most recent round. Maps from AMNET reports are shown at full size in the Appendix.

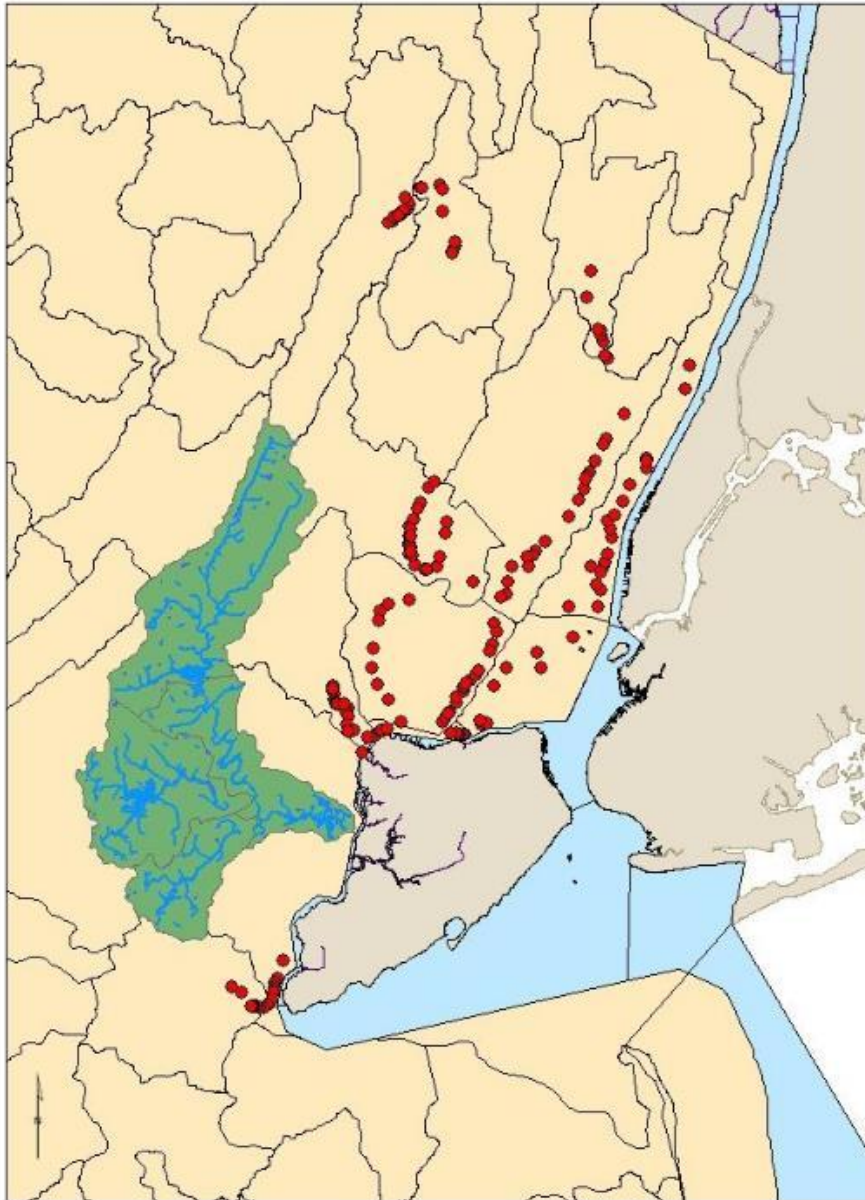
While neighboring communities are plagued by Combined Sewage Overflows, these are not generally a problem for the Rahway River watershed towns, where the two systems use a different set of pipes. However, unintended infiltration of the sanitary sewers by stormwater does occur and can result in sewage overflow. Digital files of storm water outfalls are available in some watershed municipalities, but we have not, so far, found a county or state level layer.

Combined Sewer Outflows (CSOs), Northern NJ
